FORM B - BUILDING

Form Number
1088

Address 335 Marrett Road

BUILDING FORM (335 Marrett Road)

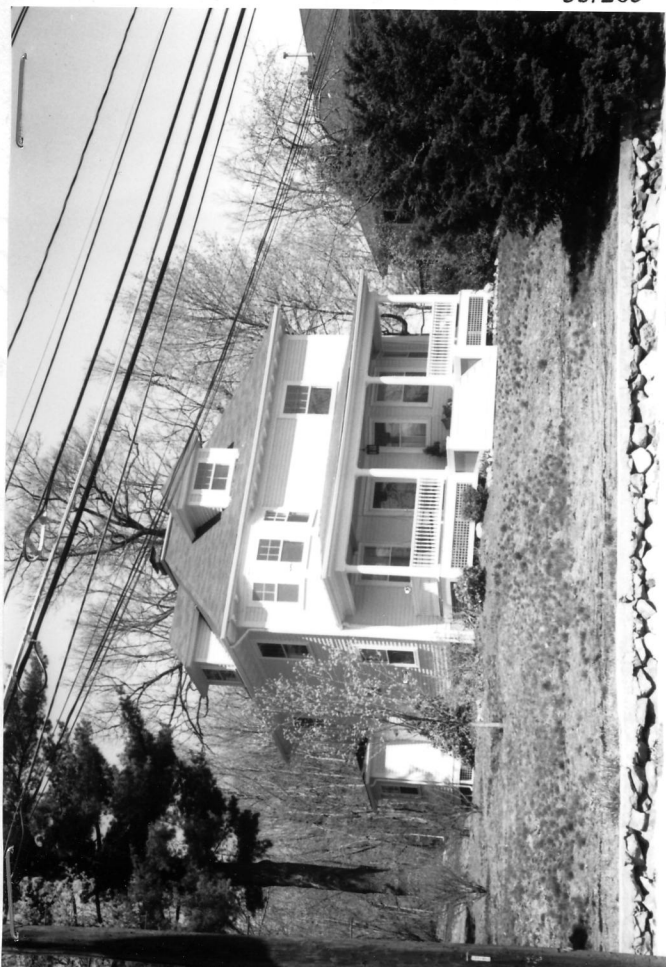
Located near the intersection with Waltham Street, 335 Marrett Road is a two-story, hip-roofed dwelling constructed in the early 20th century. The clapboarded house is outlined by simple cornerboards with short beams decorating the underside of the overhanging eaves. The truncated hip roof exhibits eaves which are flared slightly. Spanning the main facade is a single-story porch supported by four Roman Doric columns with a turned balustrade set above a wooden deck with a latticed airspace and wooden steps. The offcenter entrance contains a six-panel door (not original). On one side of the entrance there is a three-sided bay window and on the other there is a single window; all contain 1/1 sash. On the second floor of the facade the window placement is reversed and the windows retain their original sash configuration, with a three-sided bay window consisting of a 6/1 and two 4/1 sash set above the individual window and an individual 8/1 window located above the first floor bay window. A hip dormer containing an 8/1 window is centered on the front and side elevations.

On the east side of the house there is a two-story, three-sided bay window. Remaining windows consist primarily of 8/1 and replacement 1/1 sash. There is a small stained glass window on the west side. The rear porch at the northwest corner of the building has been partially enclosed in recent years but retains a single turned post.
